MITSUBISHI MOTOR SALES OF AMERICA, Inc.

TECHNICAL SERVICE BULLETIN

SUBJECT: **REAR WINDOW DEFOGGER GRID REPAIR**

NO.	TSB-95-54-001
DATE	October, 1995
MODEL	All Models

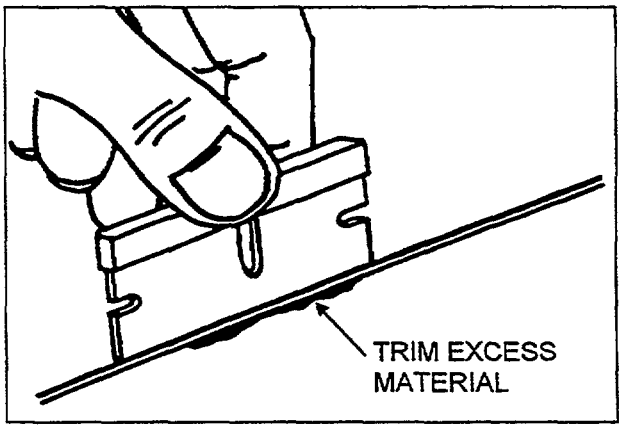
The rear window defogger grid lines can be damaged by improper window cleaning procedures or by objects placed in the rear window area causing a small scratch on the grid line(s). An open circuit results when the grid line is scratched or otherwise damaged.

To improve the appearance of the repaired grid section, wait 30 minutes after applying the repair material, then carefully trim the excess material from the width of the repaired section with a sharp blade.
